# SURP Case Studies

## The Marwell Tar Pit Remediation

The Marwell Tarpit during remediation

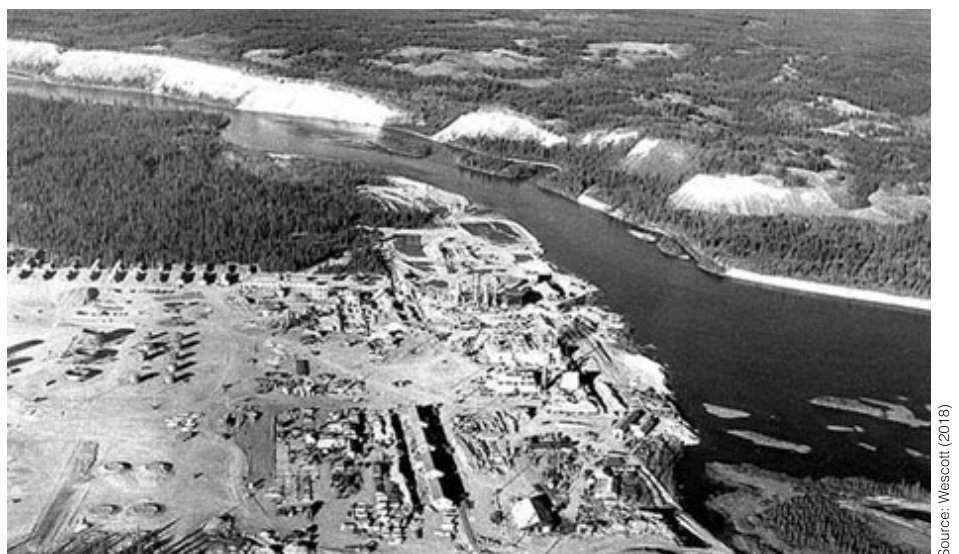
Figure 2. Image of the Marwell Tar Pit site during its use as a refinery in the 20<sup>th</sup> Century.

The Marwell Tar Pit is a 2.5 acre publicly owned site, legally identified as Lot 263, CLSR Plan 8406<sup>3</sup>. In 1944, the pit was part of the development site of the Whitehorse Canol oil refinery, (Figure 2) which was a component of the Canol Project to develop aviation fuel for

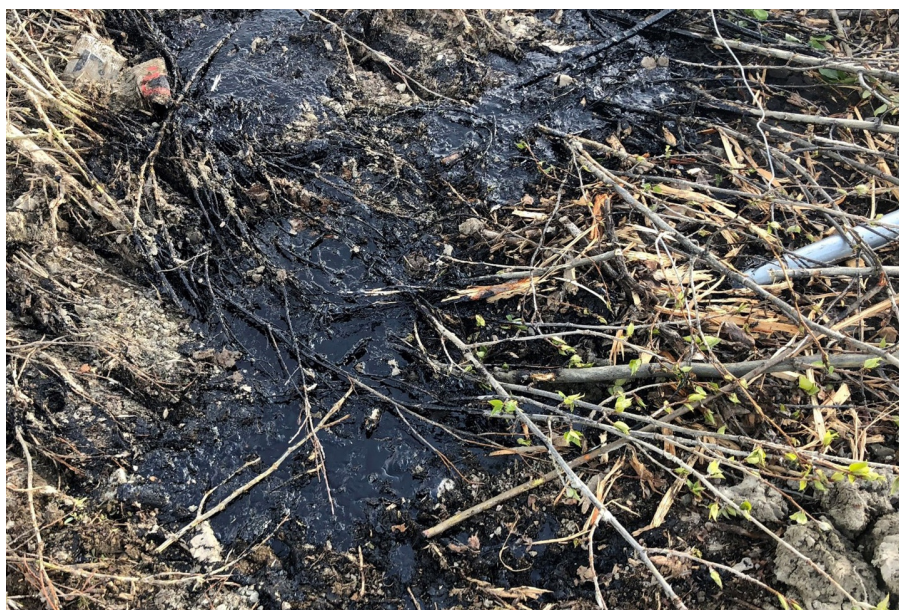
Figure 3. Exposed tar at the Marwell Tar Pit before remediation.

wastes by the Canadian army and surrounding businesses<sup>7</sup>. It was not until 1958 when a pedestrian walking through the area became stuck in exposed tar (Figure 3) and died from hypothermia, that the contamination became a public health issue and the pit was recommended for remediation<sup>8</sup>. In 1960 it was estimated that approximately half the contamination deposited on the site remained; although there was no consensus on who should be responsible for cleaning it up<sup>9</sup>. The parcel was transferred to the Yukon Government in 1970 following a federal block transfer, who then drained, capped, and monitored it afterwards<sup>10</sup>. Subsequent sampling by Environment Canada in 1989 revealed that contamination was still present and moving towards a creek to the northeast<sup>11</sup>. In 1990, a Phase 1 and partial Phase 2 Environmental Site Assessment identified 27,000 m<sup>3</sup> of contaminated soil and groundwater that was migrating towards Jasper Road and the nearby creek, and the site was officially designated as a Contaminated Site by the Yukon Government in 1998 under the Contaminated Sites Regulation of the Environment Act<sup>12</sup>. Following years of talks between the two levels of

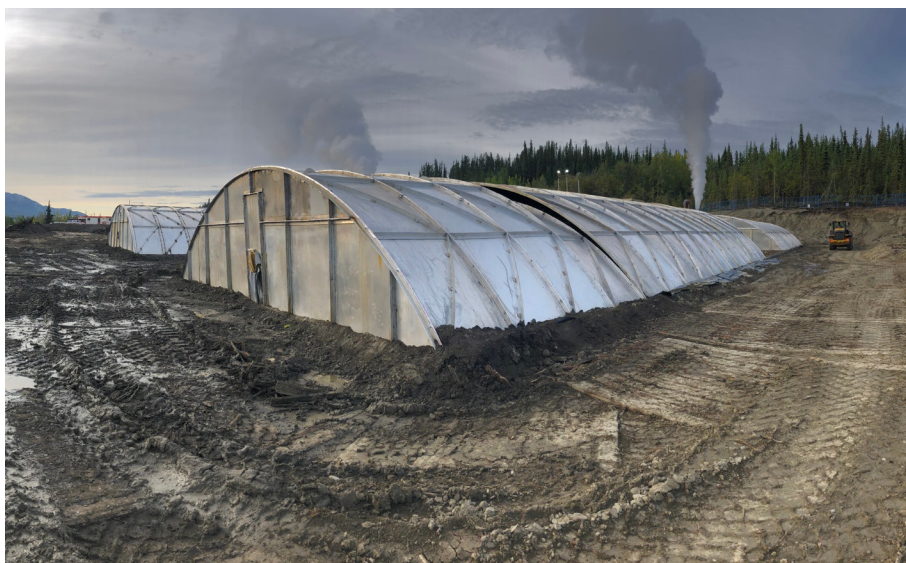
**Figure 4. Image depicting the enhanced thermal conduction system used to treat contaminated soil at the Marwell Tar Pit.**

The second phase involved remedial activities for contaminated surface water and soil, which were completed by Milestone Environmental Contracting and Iron Creek Group between 2018 to 2019<sup>18</sup>. Soil was treated using enhanced thermal conduction (Figure 4). Contaminated soil was excavated and stored in temporary Quonset huts with multi-fuel burners, was heated to temperatures between 260-425°C for 4-12 day periods until contaminants vapourized, and vapours were further burned off into non-harmful by-products and removed through steam to meet air quality guidelines<sup>19</sup>. Soil was treated throughout all seasons over 11 months, and a majority of the contamination was addressed given 36,000 tonnes of soil were excavated, cleaned, and backfilled on-site<sup>20</sup>. The concentrations of HEPH and LEPH in treated soil decreased by ~98% following the remediation<sup>21</sup>. The treatment process was found to be more successful than believed, as the final concentrations of HEPH and LEPH were also ~97% lower than the original site specific

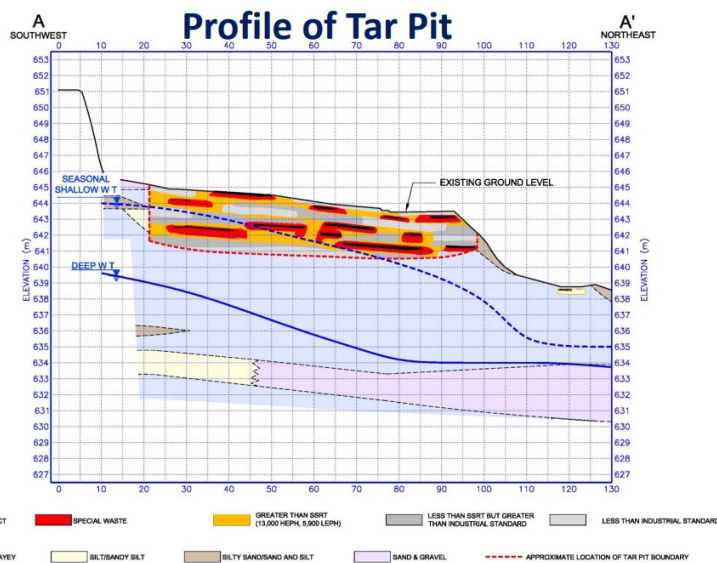
**Figure 5. Chemical and topographical profile of the Marwell Tar Pit depicting site constraints.**

springs and a shallow and perched groundwater table<sup>34</sup>. In addition, the site's contaminated soil consisted of a mix of silt, clay, and sand, and was concentrated in specific pockets at varying depths where historic dumping was most frequent (Figure 5)<sup>35</sup>. This resulted in an uneven distribution of hydrocarbon contamination which limited the ability to use more conventional treatment approaches, such as in -situ chemical remediation or bioremediation<sup>36</sup>. Due to the site's complex history, the development also required the involvement and perspectives of several jurisdictions and stakeholders, including the federal, territorial, and local governments, First Nations communities, and nearby business owners and residents<sup>37</sup>. This required constant communication and collaboration between parties and made it difficult to identify what the site would become and who would be responsible for its outcome. These barriers were navigated through a careful planning process that identified goals, responsibilities, and the appropriate methods to ensure that risks were adequately and cost-effectively managed and that the future of the site would be open to further consultation opportunities with the community. A particular strength of the project was its ability to reduce costs and manage concerns identified during the community consultation process by conducting the remediation on-site to avoid the need for hauling soil off-site for treatment, and conducting regular air quality monitoring to ensure that risks to surrounding residents were not present or identified and addressed immediately.

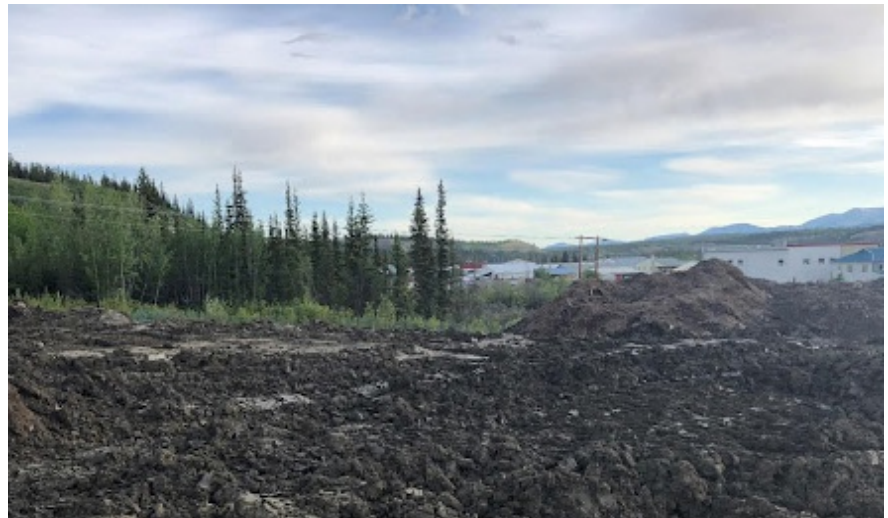
Figure 6. Image showing the site terrain at the beginning of remediation.

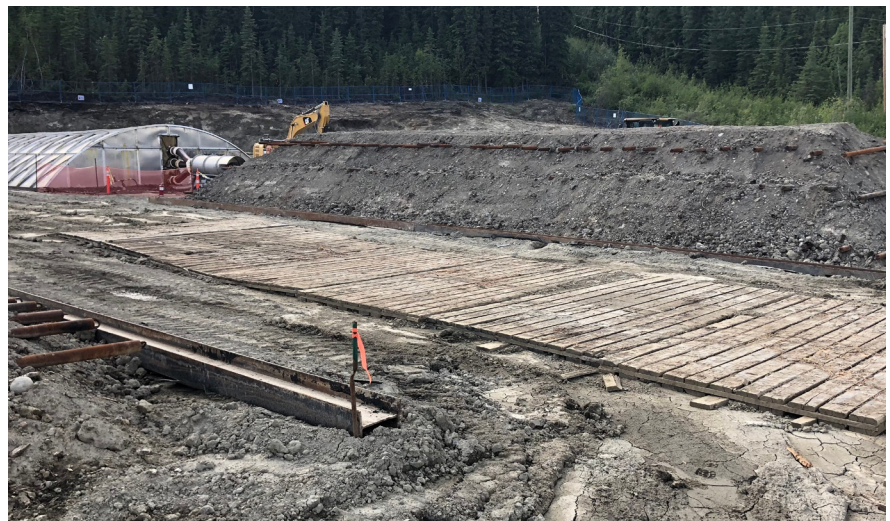
Figure 7. Image showing the storage and treatment of contaminated soil on-site.

The Marwell Tar Pit project can provide practitioners with tangible lessons for remediating legacy postwar contaminated sites. First, a publicly-led financing strategy was imperative when working on a smaller, publicly owned lot to ensure it did not sit vacant. Next, this project highlights a successful process to navigate constraints seen during the remediation of a contaminated northern site, including site size and topographic restrictions, sporadic soil and contaminant characteristics, and climatic limitations (Figure 6). Lastly, the remediation approach was designed to reduce community impacts by storing soil away from public view, avoiding hauling soil off site, and maintaining strict air quality monitoring and noise mitigation standards (Figure 7).

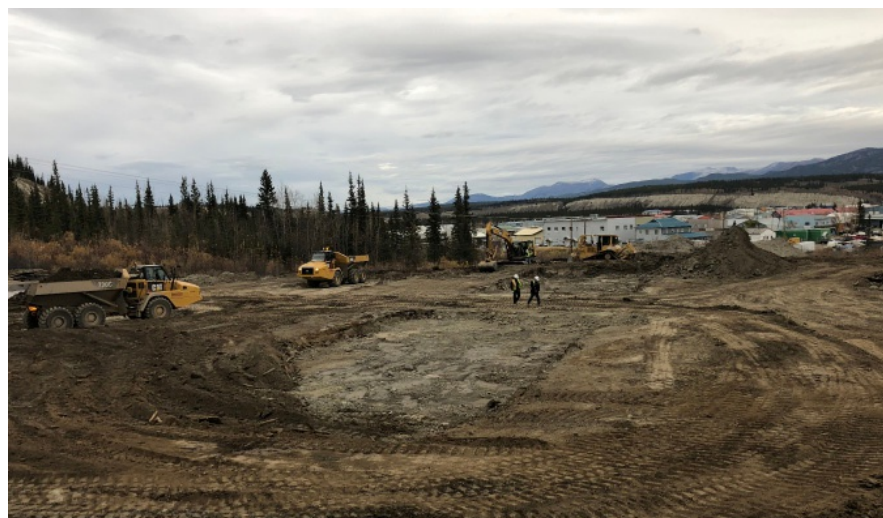
Figure 8. Image showing the site after excavation and prior to backfilling.
